# Agenda for Facilities & Services Committee Monday 21 July 2025 – 4:00pm

# **ANNUAL PLAYGROUND SAFETY INSPECTION**

# Sunningdale Parish Council Tuesday 11th February 2025

**Inspection** # INS11022025 1304-682

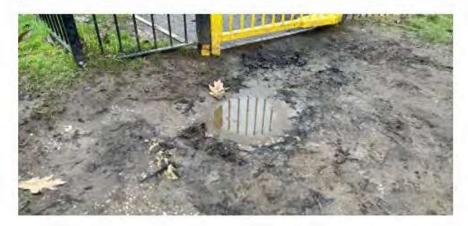
### Finding For: Access Gate

| | The ground inside the gate is badly warm leaving muddy puddles but more importantly there is exposed sharp concrete that can be tripped on or cause injury when landed on |
| Risk Level | Medium |

| | The ground inside the gate is badly warm leaving muddy puddles but more importantly there is exposed sharp concrete that can be tripped on or cause injury when landed on |
|---|---|
| Action Required | Remove the concrete and all trip points and build up the ground to make safe |

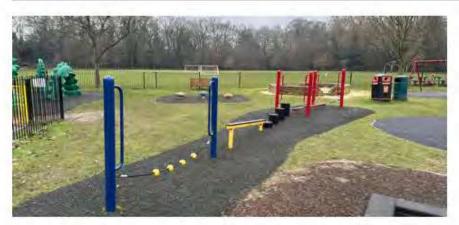
# Finding For: Agility Trail

| Finding | The eyelet bolts and links are wearing and are close to the minimum 40 mm |
| Risk Level | Low |

| Finding | The eyelet bolts and links are wearing and are close to the minimum 40 mm |
|---|---|
| <b>Action Required</b> | Replace the eyelet bolts and links |

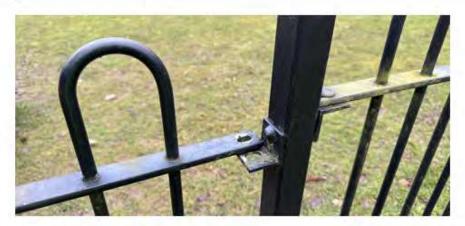
## Finding For: Ancillary: Perimeter Fencing

| | There are fixings missing on the field side of the fence next to the picnic benches leaving a crush and shearing point |
| Risk Level | Medium |

| | There are fixings missing on the field side of the fence next to the picnic benches leaving a crush and shearing point |
|---|--|
| <b>Action Required</b> | Secure the fence to eliminate the risk |

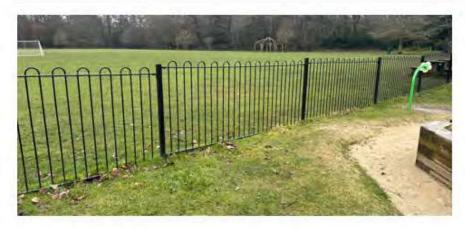
### Finding For: Ancillary: Perimeter Fencing

| Finding | There are several loose fence posts along the field side of the fence |
| Risk Level | Low |

| Finding | There are several loose fence posts along the field side of the fence |
|---|---|
| <b>Action Required</b> | Reset and secure the post |

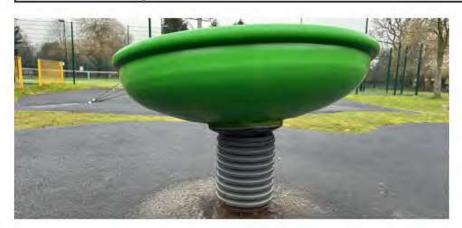
# Finding For: Carousel - Dish Spinner

| IEINAINA | The bearing has failed, which will now cause excess wear on the main structural elements |
| Risk Level | Low |

| IEINAINA | The bearing has failed, which will now cause excess wear on the main structural elements |
|--|--|
| Action Required Replace the damaged failed bearing | |

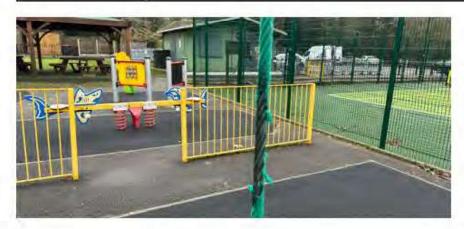
## Finding For: Multiplay Unit - Timber Frame

| | The rope on one of the suspended tires has been set a light burning off all of the rope and exposing the steel core |
| Risk Level | Low |

The last inspection (Feb 2025) flagged that the rope on one of the suspended tyres had been burnt and was exposing the steel core. The risk level is low, and the action required was to replace the section of rope.

| | The rope on one of the suspended tires has been set a light burning off all of the rope and exposing the steel core |
|---|---|
| Action Required Replace the section of rope | |

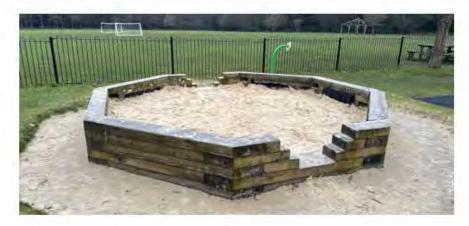
# Finding For: Sandpit

| Finding | The sand level is getting low, exposing the membrane in places |

We have requested some quotes for a replacement sand pit that would be more accessible.

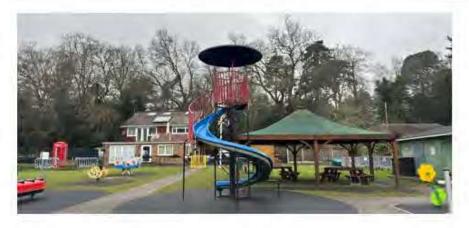
# Finding For: Slide

| Finding | The coating of the slide section is beginning to wear away |

The slide, which is made of fibreglass could do with being replaced, and the slide has been in the park for 60 years, so we can't buy replacement parts, a bespoke replacement slide would need to be manufactured to fit the frame.

The last inspection (Feb'25) advised that the coating of the slide is wearing away and should be monitored for further deterioration. The risk is low. The frame and slide have been recently sanded down and painted.

| Finding | The coating of the slide section is beginning to wear away |
|---|--|
| <b>Action Required</b> | Monitor for further deterioration |

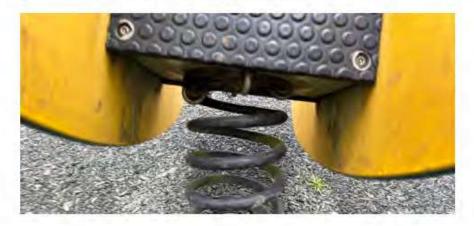
# Finding For: Spring Rocker - Generic

| IFINAINA | The spring to body connection is loose making noises and with excess movement |
| Risk Level | Low |

| IFINAINA | The spring to body connection is loose making noises and with excess movement |
|---|---|
| <b>Action Required</b> | Tighten the item to secure |

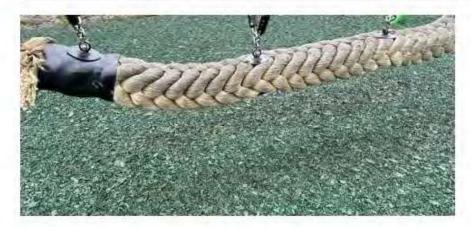
# Finding For: Swing - Viper Rope Seat

| Finding | The rope is too low. This needs to be a minimum of 400mm |
| Risk Level | Low |

| Finding | The rope is too low. This needs to be a minimum of 400mm |
|---|---|
| <b>Action Required</b> | Adjust the height by removing links to give the correct clearance |

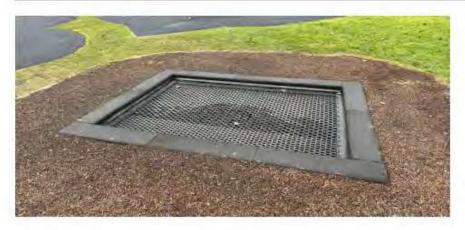
# Finding For: Trampoline

| Finding | Some of the rubber bed links are breaking due to wear and tear and age |

The trampoline was installed in 2006, and it has reached the end of its life. The latest inspection (Feb'25) advised that some of the rubber bed links are breaking due to wear & tear and its age. The risk is low, and action required is to monitor and replace/repair during routine maintenance.

| Finding | Some of the rubber bed links are breaking due to wear and tear and age |
|---|--|
| <b>Action Required</b> | Monitor and replace/repair during routine maintenance |

We have requested a quote to replace the trampoline, to the same specification.
