# Agenda for Facilities & Services Committee Monday 21 July 2025 – 4:00pm

# **ANNUAL PLAYGROUND SAFETY INSPECTION**

# Sunningdale Parish Council Tuesday 11th February 2025

**Inspection** # INS11022025 1304-682

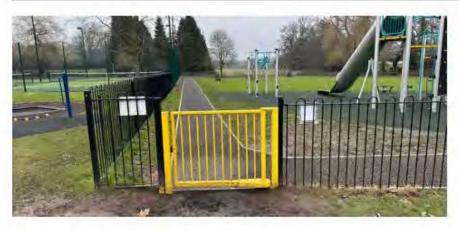
### Finding For: Access Gate

| | The ground inside the gate is badly warm leaving muddy puddles but more importantly there is exposed sharp concrete that can be tripped on or cause injury when landed on |
| Risk Level | Medium |

| | The ground inside the gate is badly warm leaving muddy puddles but more importantly there is exposed sharp concrete that can be tripped on or cause injury when landed on |
|---|---|
| Action Required | Remove the concrete and all trip points and build up the ground to make safe |

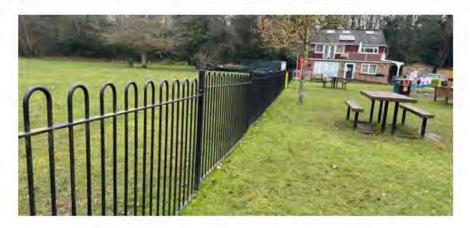
## Finding For: Ancillary: Perimeter Fencing

| | There are fixings missing on the field side of the fence next to the picnic benches leaving a crush and shearing point |

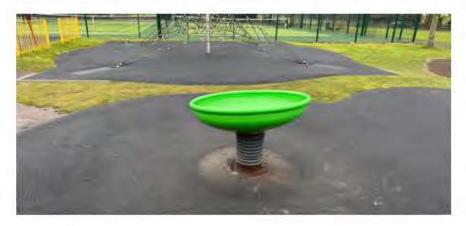
# Finding For: Carousel - Dish Spinner

| IEINAINA | The bearing has failed, which will now cause excess wear on the main structural elements |

| IEINAINA | The bearing has failed, which will now cause excess wear on the main structural elements |
|--|--|
| Action Required Replace the damaged failed bearing | |

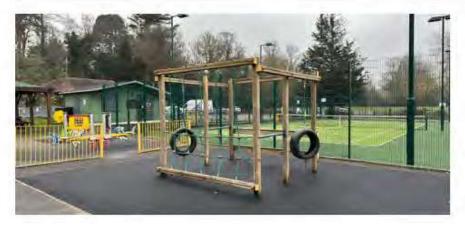
## Finding For: Multiplay Unit - Timber Frame

| | The rope on one of the suspended tires has been set a light burning off all of the rope and exposing the steel core |

The last inspection (Feb 2025) flagged that the rope on one of the suspended tyres had been burnt and was exposing the steel core. The risk level is low, and the action required was to replace the section of rope.

| | The rope on one of the suspended tires has been set a light burning off all of the rope and exposing the steel core |
|---|---|
| Action Required Replace the section of rope | |

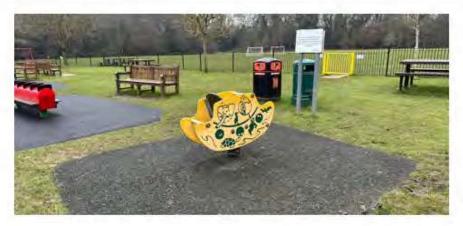
# Finding For: Spring Rocker - Generic

| IFINAINA | The spring to body connection is loose making noises and with excess movement |

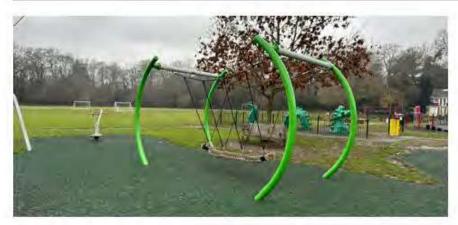
# Finding For: Swing - Viper Rope Seat

| Finding | The rope is too low. This needs to be a minimum of 400mm |
